USAAMRDL TECHNICAL REPORT 71-47

EVALUATION OF THE UH-1D/H HELICOPTER CRASHWORTHY FUEL SYSTEM IN A CRASH ENVIRONMENT

November 1971

**CONTRACT DAAJ02-69-C-0030
DYNAMIC SCIENCE ENGINEERING OPERATIONS
A DIVISION OF MARSHALL INDUSTRIES
PHOENIX, ARIZONA**

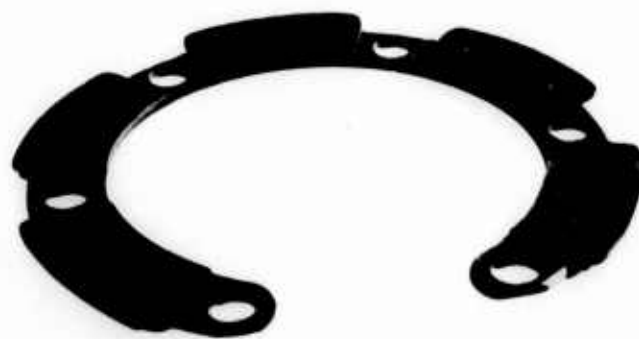
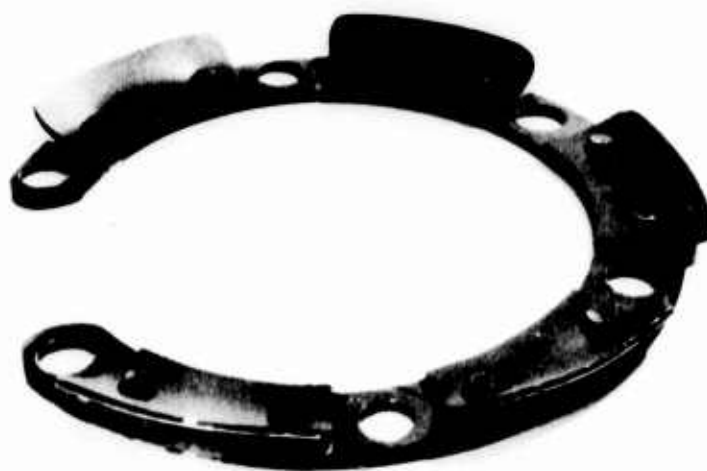
Figure 1. Frangible Retainer Before and After Testing (Bending Load Application).

Appendix V presents the methodology and results of a series of dynamic tests performed on frangible retainers proposed for use in attaching fuel cells to airframe structure. Figure 1 shows a typical design before and after dynamic testing. The frangible action is obtained by bending of the clips and/or failure of the rivets.

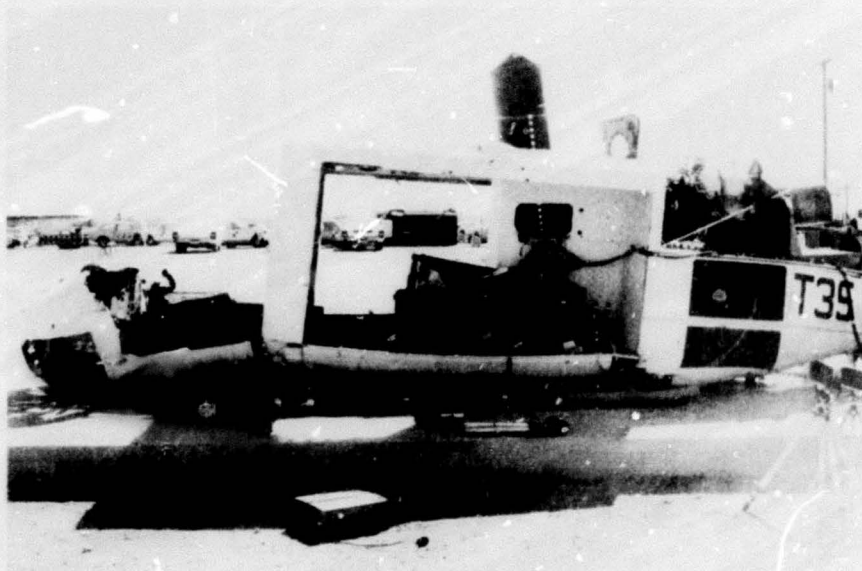
Figure 12. Fuselage Deflection - Left Side (Test 1).

The impact attitude of the test vehicle was approximately the same as the release attitude: 2 degrees nose-down pitch and 0 degrees roll. No appreciable energy appeared to be absorbed during the descending aircraft's envelopment of the rocks and stumps. The floor panels above both underfloor cells were torn free of the structure, and the entire nose section was ruptured and settled on the pad as shown in Figure 11. The tail section also yielded and partially separated from the main fuselage section as shown in Figure 12.

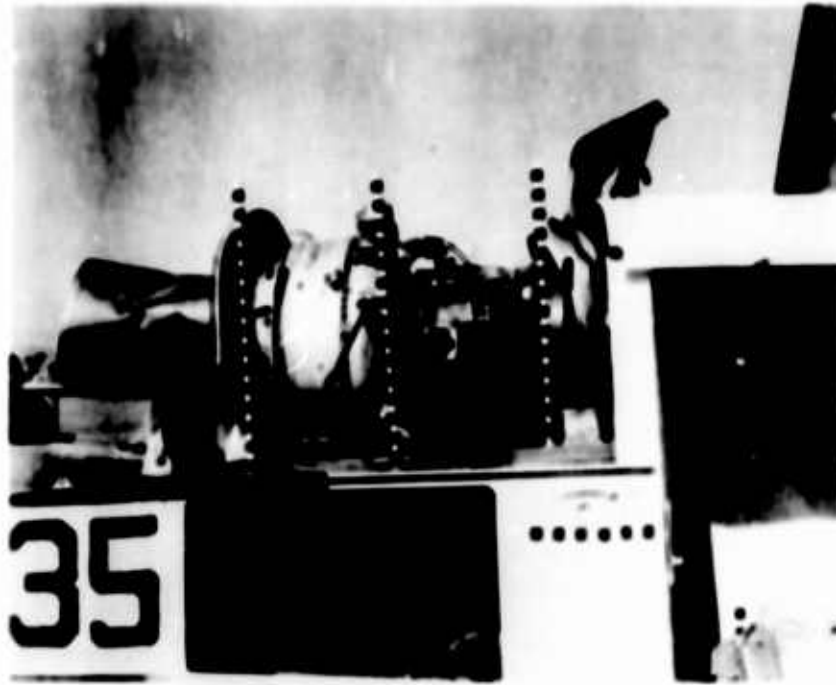
Figure 15. Posttest Position of Engine
(Test 1).

The engine broke free of the right engine mount when the trunnion bolt sheared. This allowed the engine to roll onto its right side on the service deck (Figure 15). Both left and right engine mounts buckled, the left side more than the right. Both fuel hoses, firewall-to-filter and filter-to-engine, remained intact, although the left forward link put a slight crimp in the filter-to-engine hose.

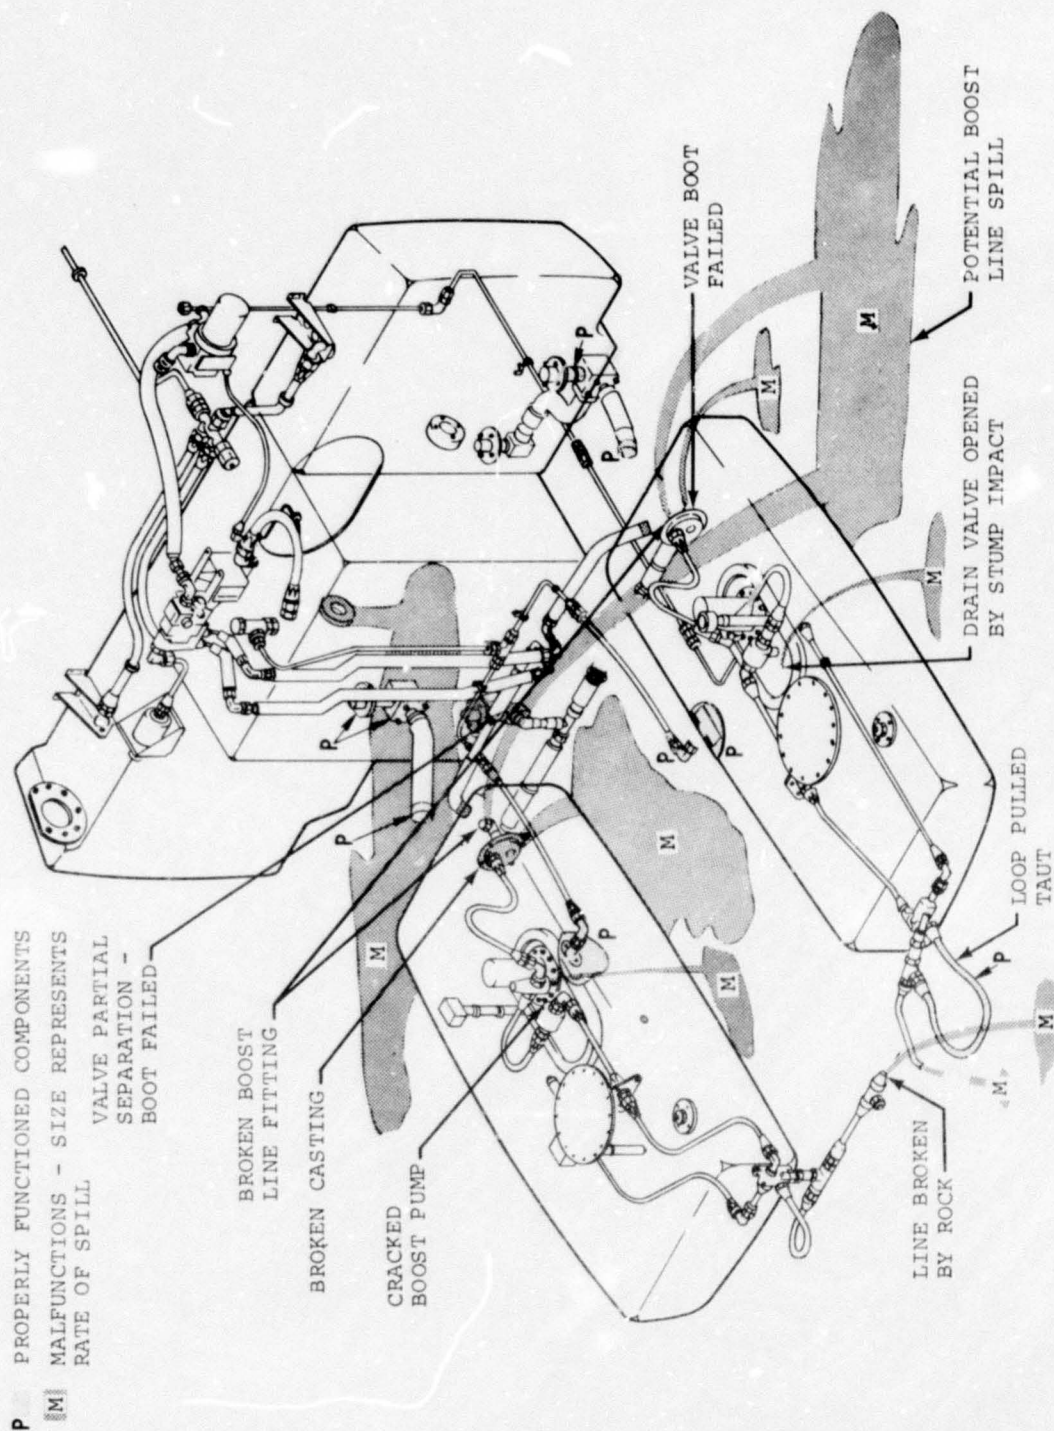
Figure 20. Summary of Actual and Potential Fuel System Spillage (Test 1).

Figure 20 is a general illustration summarizing the spillage and potential spillage from the system.

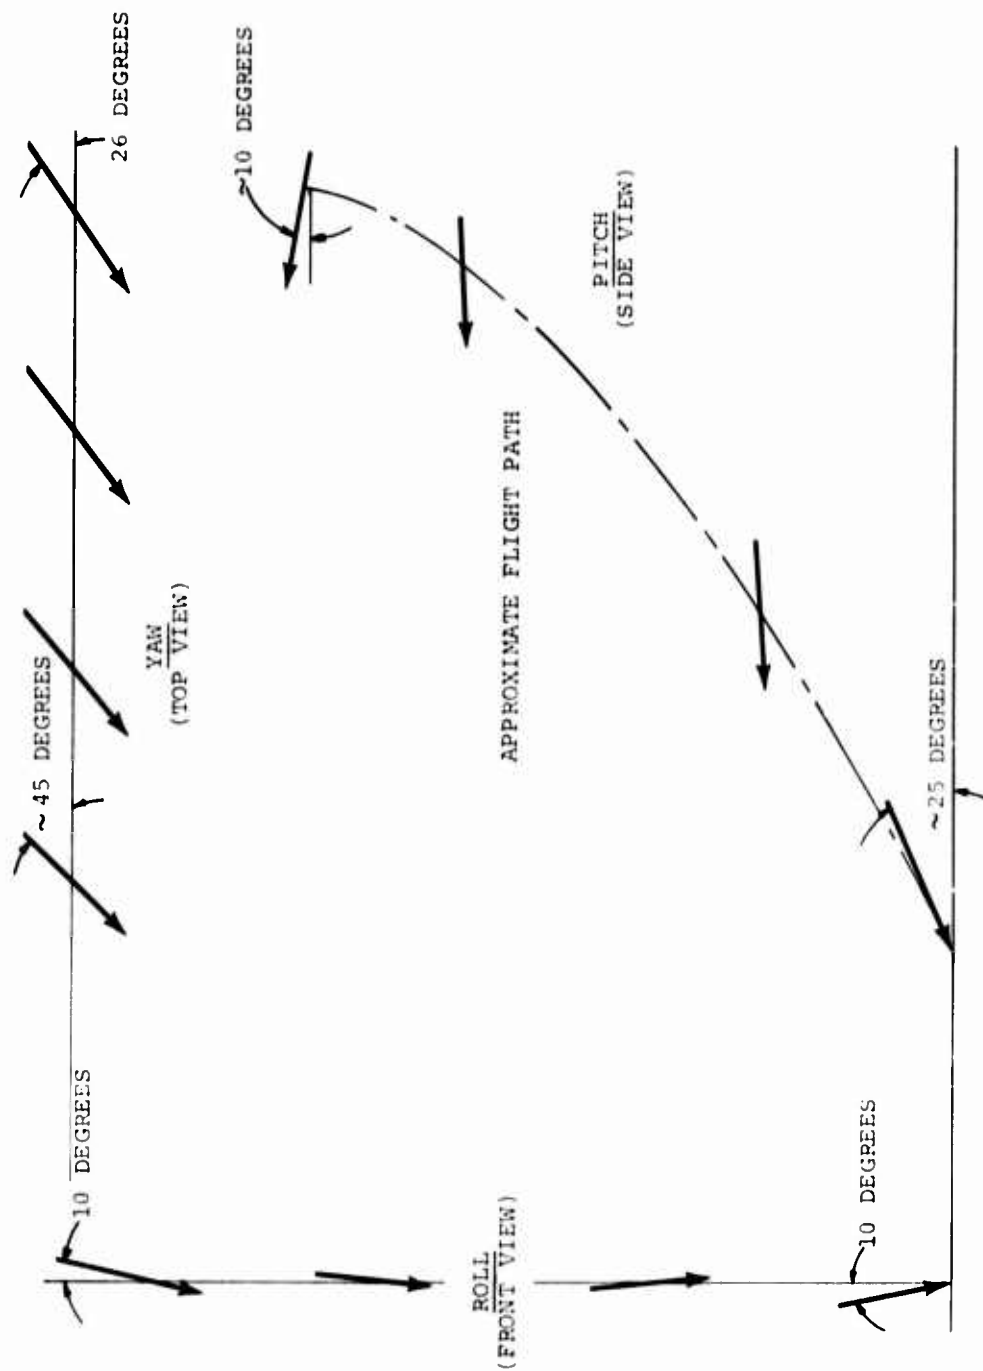
Figure 34. Vehicle Attitude Change (Test 2).

The top half of the transmission failed, and its tie-bolts broke away from its base. The engine buckled its mounts and was displaced downward and to the right, but the fuel lines remained in place. The landing skid was severely damaged, and the tail boom was also badly buckled. The remainder of the aircraft suffered considerable deformation of the right forward area. The major portion of this damage did not extend to the left side of the aircraft, as Figure 35 indicates. The high-speed films revealed two reasons for the minimal damage to the fuselage. As the vehicle rotated into a nose-down attitude, its effective drop height was diminished by approximately 6 feet, as Figure 34 illustrates. Second, the whipping of the cable induced by the initial jerk of the trolley put a considerable bind on the guides throughout the entire sequence, thereby greatly increasing the friction in the system and causing a further reduction of the velocity. The actual striking velocity was determined by scaling the high-speed

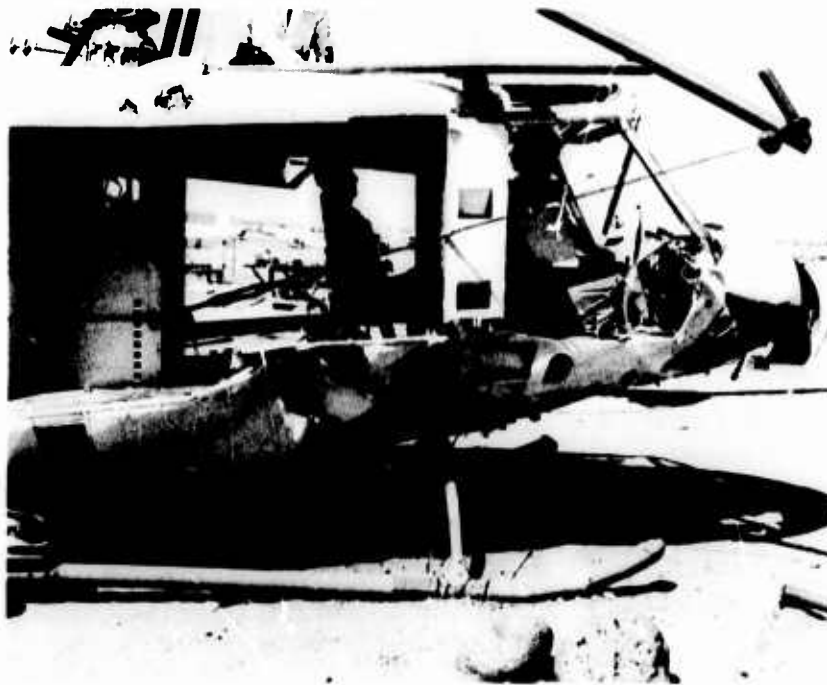
Figure 36. Preparations for Test 3.

The damaged gear was replaced with the gear from another UH-1 helicopter. Some additional guying was necessary to keep the right side of the forward cross tube in place because of the structural deformation sustained in Test 2 (see Figure 36).

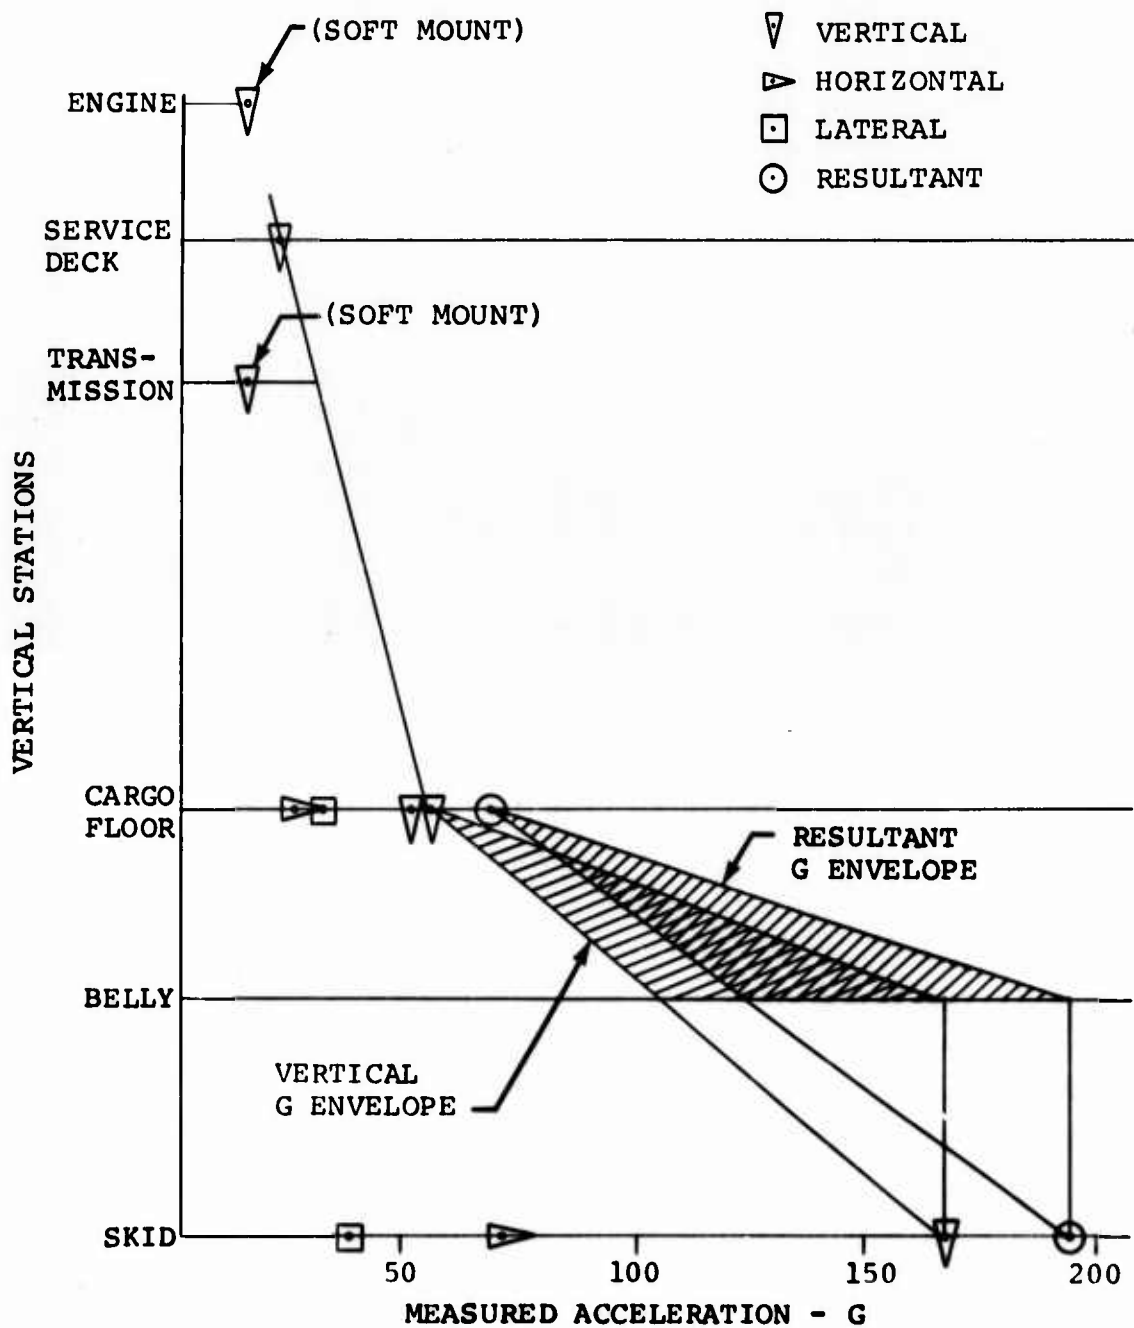
Figure 47. Test 3 Peak Acceleration Profile.

Acceleration data from Test 3 revealed a profile of peak accelerations ranging from 14 to 200G. Figure 47 presents a profile of peak acceleration taken from accelerometers mounted on the solid structure of the aircraft. The resultant accelerations seen by the underfloor ranged between 70 and 200G. It is assumed that direct rock or stump impact on components (such as the aft inlet/outlet valve) would have resulted in an acceleration load near the maximum, whereas the acceleration transmitted through the structure probably would have been somewhat lower. Even assuming the maximum G level and disregarding the direction of the load or the mass of the hose supported by the fitting, it is doubtful that any of the breakaway valves would have been functioned by accelerations alone.

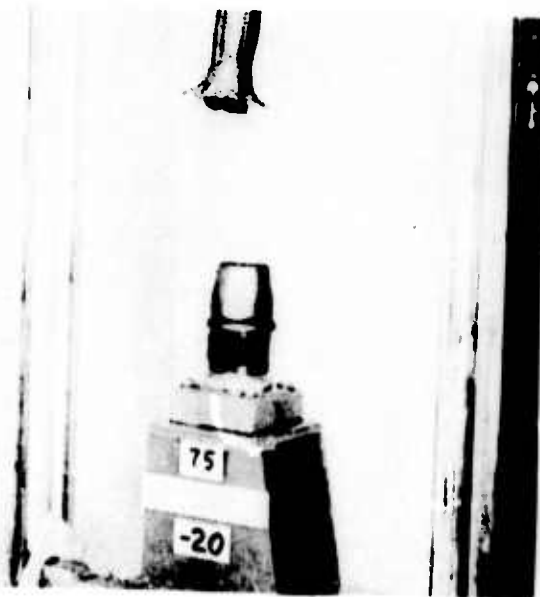
Figure 50. Typical Straight End-Fitting Combination Following Tension Load Application.

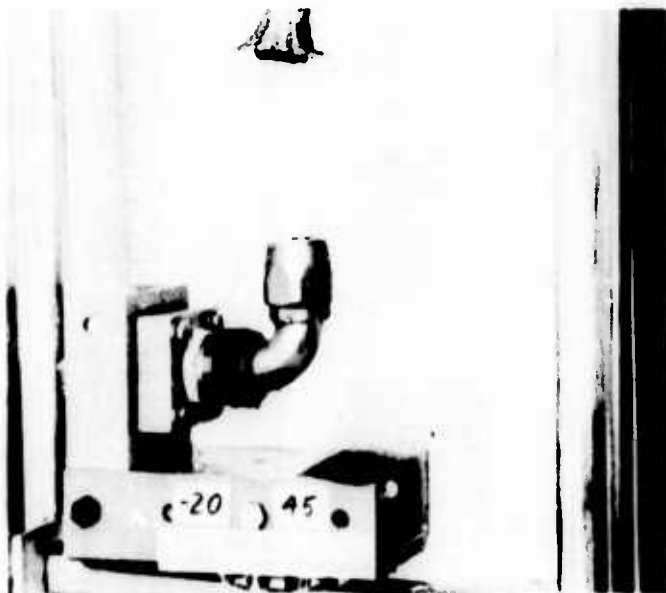
Figure 54. Typical Tube Elbow End-Fitting Combination Following Tension Load Application.

In general, the test results complemented existing test data. Hose sizes which had not been previously tested produced values compatible with existing data with two exceptions: (1) -4 (1/4 inch) 90-degree tube elbows and (2) -8 (1/2 inch) straight end fittings. The -4 90-degree tube elbows, when subjected to a bending load, failed at values only 50 percent of those of a previous test series. Tension loads on five -8 straight end fittings resulted in widespread values.

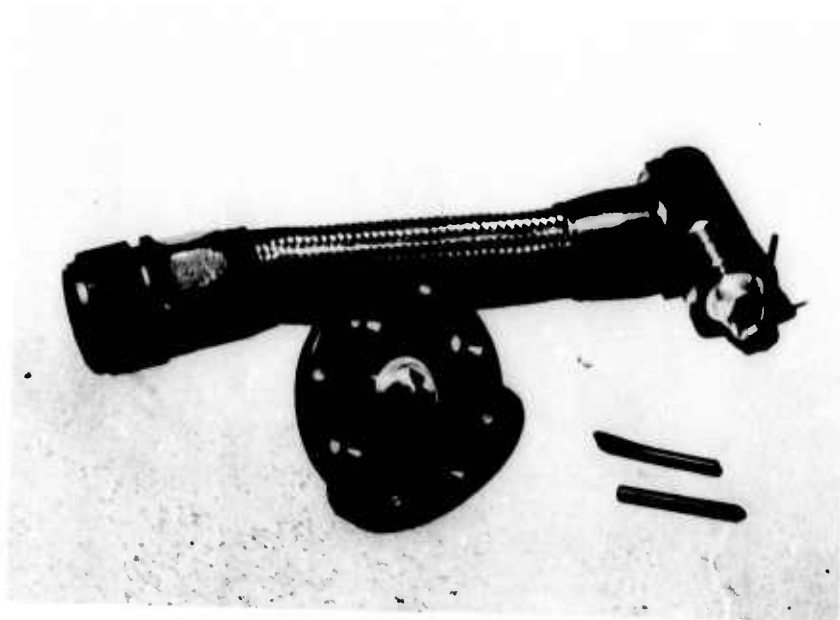
Figure 68. View of -12 Valve After Dynamic Bending Test.

The loads were applied to the end of the connecting hose at a rate of 83.0 feet per second for the -12 valve and at a rate of 73.4 feet per second for the -20 valve. The force applied through the hose caused frangible section separation and triggered the poppets. The peak forces recorded were 1,825 pounds for the -12 valve and 3,330 pounds for the -20 valve. All poppets sealed properly, and no leakage was observed other than of the fluid which was trapped in the boot during valve closure. Figure 68 illustrates the -12 valve after removal from the sled.

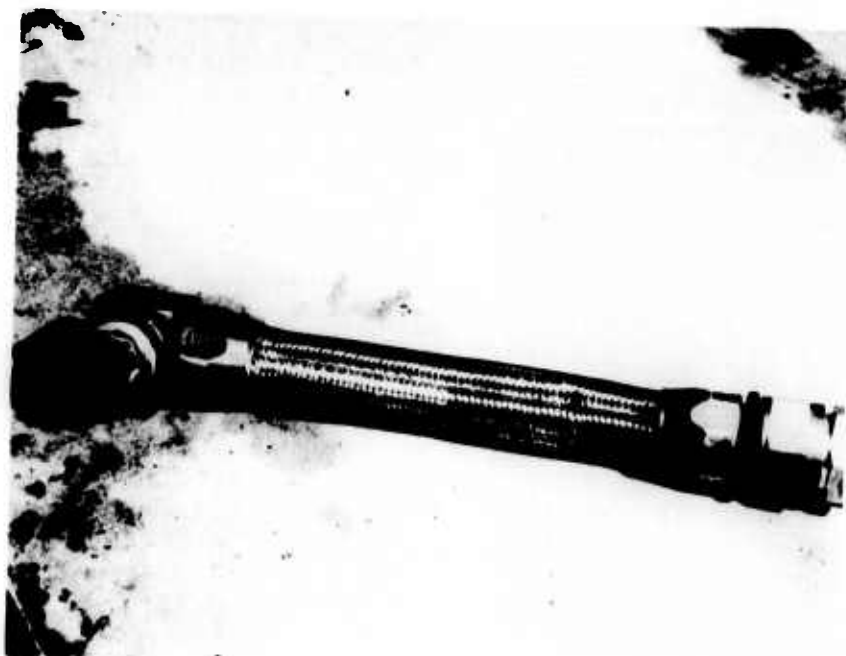
Figure 69. View of Line Half of -20 Valve After Dynamic Bending Test.

Figure 69 illustrates the line half of the -20 valve following load application. The entire boot portion of the -20 valve remained in the flange half of the valve. This boot was cut in two places prior to pulling free of the hose half of the valve (Figure 70).

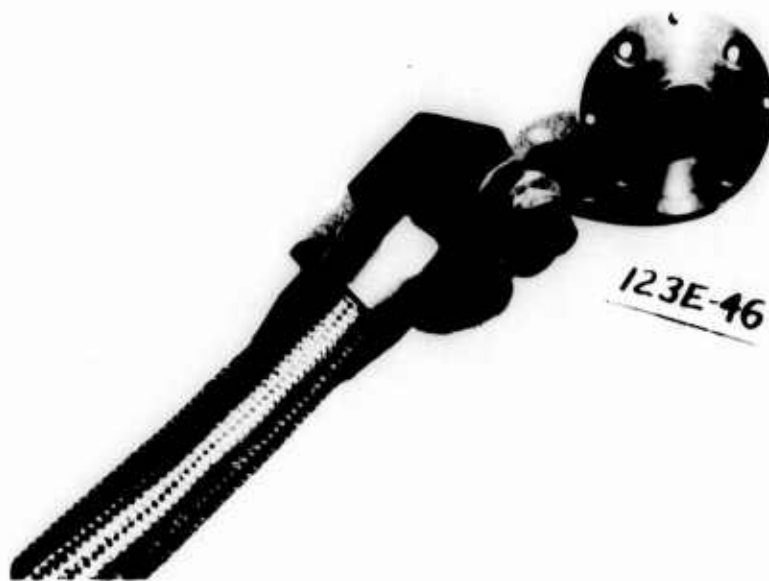
Figure 71. View of -20 Valve After Dynamic Peel Test.

All valve sections sealed properly in both tests, resulting in no leakage of fluid other than that which was trapped in the boots during poppet closure. Figure 71 shows the -20 valve and hose assembly after the tests.

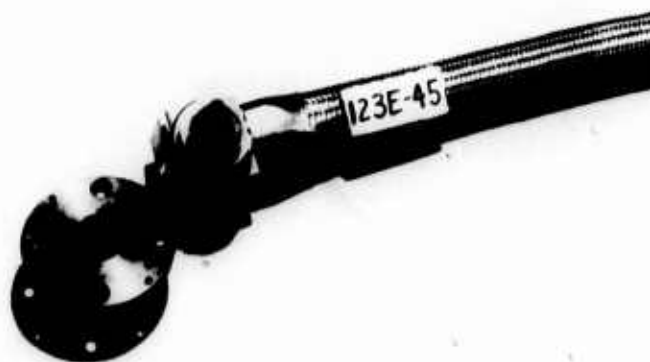
Figure 72. View of -20 Valve After Dynamic 45-Degree Impact Test.

The impact loads were applied through the impact mechanism at a rate of 68.4 feet per second for the -12 valve and 60.5 feet per second for the -20 valve. The loads recorded during impact were 817 pounds for the -12 valve and 1,270+ pounds for the -20 valve. The latter figure is not a peak load due to load cell failure at that value. Both valves functioned properly. Separations were made at the frangible sections, and no leakage was observed other than of the fluid entrapped in the boot during actuation. The -20 hose assembly and valve section were thrown over the impact barrier following impact. Figure 72 illustrates the -20 valve following dynamic impact.

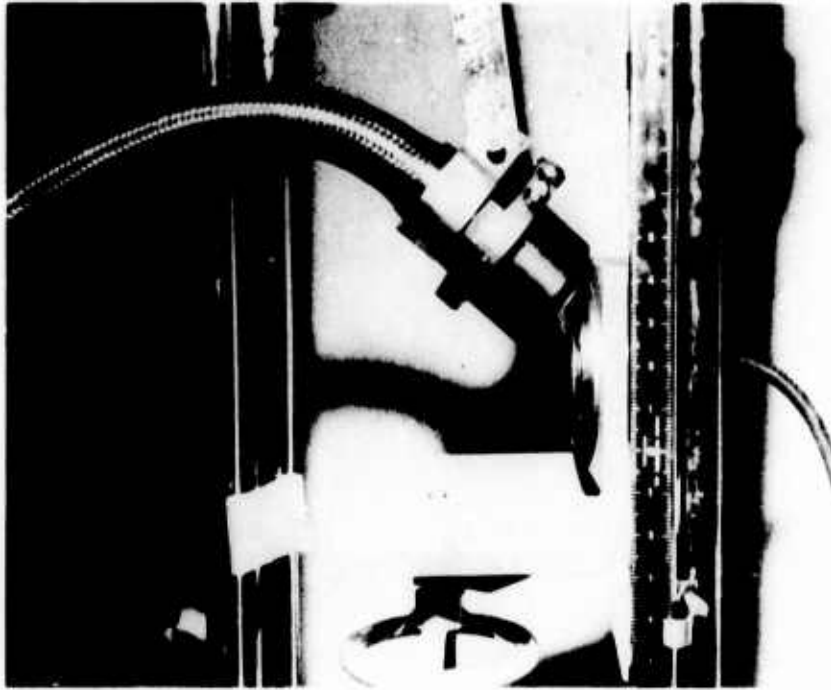
fluid flow. The frangible section yielded at 1.3 inches travel, and the peak load recorded was 1,530 pounds. No seepage occurred. Figure 79 illustrates valve position at the time of flow stoppage. Figure 80 is a close-up of the valve body after removal from the test fixture.

Figure 79. Valve Position at Time of Valve Closure During Static Bending Test.

As can be seen in Figure 79, the valve assembly bent approximately 45 degrees before closing. While the inner boot stretched and prevented fluid spillage during the valve displacement, an undesirably large amount of boot surface area was exposed. This exposed area could be cut by jagged metal or by the sharp edge of the torn frangible section.

The maximum allowable amount of exposed boot area was not previously specified; however, the need to do so is obvious. The valve manufacturer is studying the problem and is attempting to reduce the area.

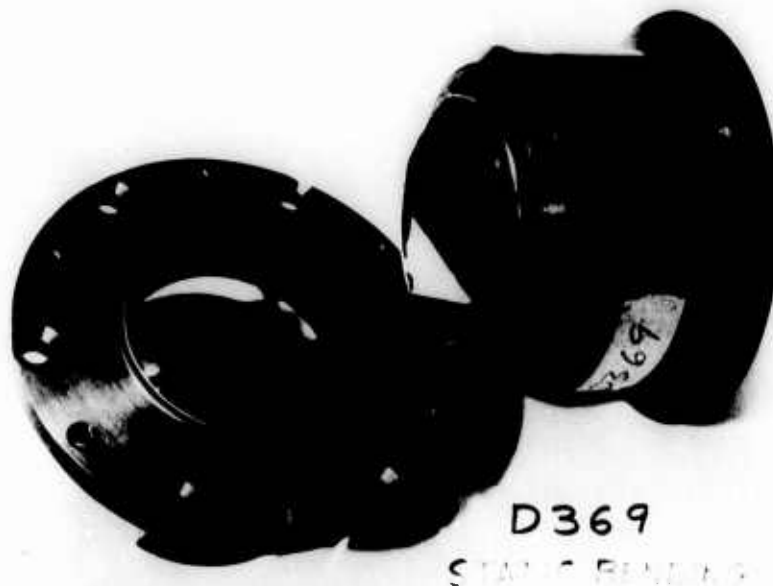
Figure 80. Valve Body After Removal From Test Fixture. (Note uncut portion of boot still holding valve halves together.)

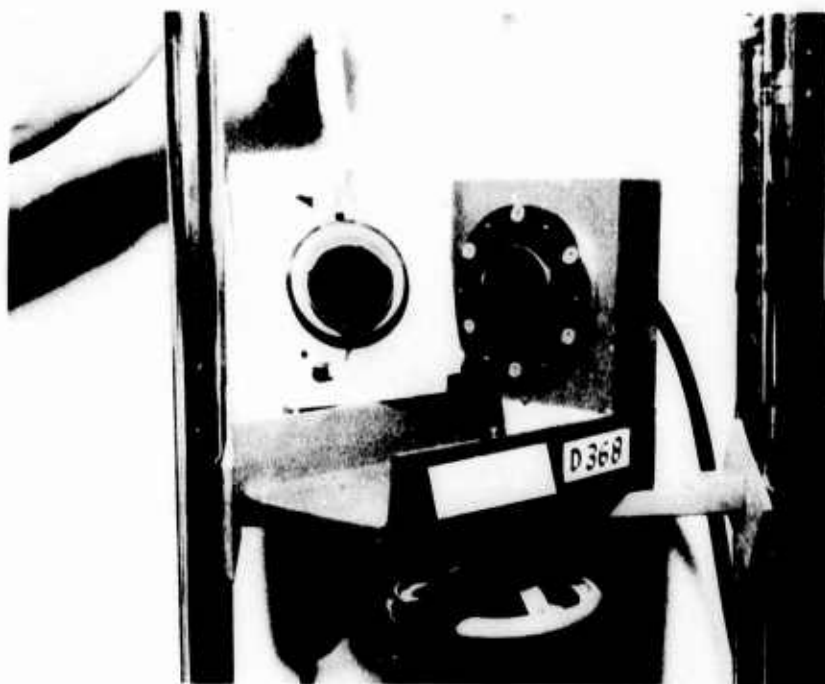
Figure 81. Valve Separation at Completion of Static Shear Test.

The test setup for this loading configuration subjected the valve to a shear loading with an effective moment arm of 0.57 inch. Static loading was applied at 1 inch per minute. Fluid dripped from the boot section at 0.9 inch head travel. Poppets closed at 0.2 inch travel and separation occurred at 1.8 inches travel. Peak load required to shear the frangible section was 3,800 pounds. Figures 81 and 82 show the test item after separation.

The fluid spillage which occurred at 0.9 inch valve displacement resulted because the jagged edge of the torn frangible section cut the boot. Upon disassembly, it was discovered that the boot was vulcanized to the inside of the frangible section. The adhesion tended to hold the boot against the cutting edge.

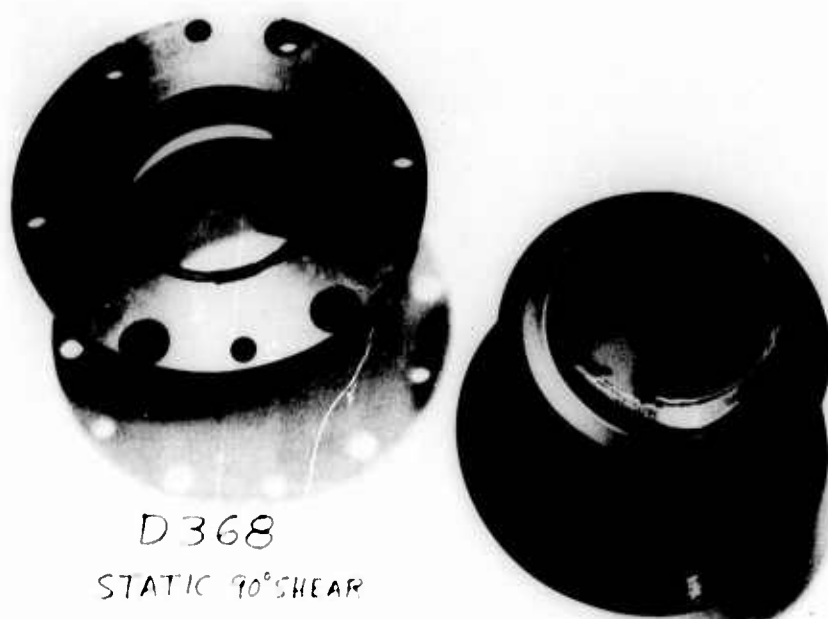
Figure 82. Valve Body After Removal From Test Fixture. (Note sharp edge on deformed shear section.)

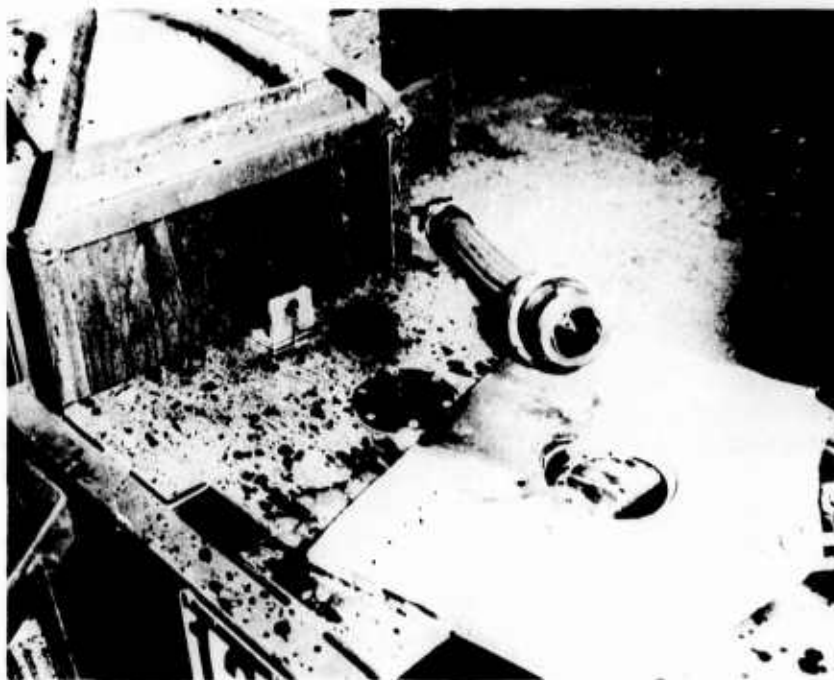
Figure 87. Valve Separation at Completion of Dynamic Shear Test.

The honeycomb panel flange impacted the valve body at approximately 65 feet per second. The entire panel sliced through the frangible section of the valve at a load of 4,100 pounds. Both valve halves sealed, with no leakage other than of fluid trapped in the valve boot between the closed poppets. Exact velocity readings were not obtained due to a malfunction in the electronic counter. Figure 87 shows the valve sections and the honeycomb panel following impact. A close-up of the valve sections is shown in Figure 88.

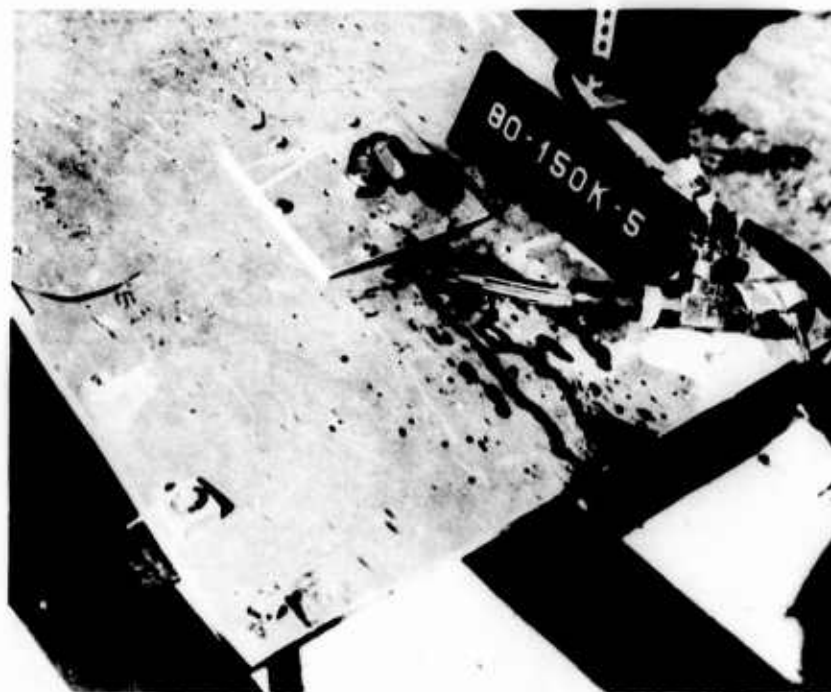
Figure 91. View of Valve A1-1/2 After Dynamic Bending Test.

Dynamic Bending - Test No. 80-150K-5: The valve and hose assembly were positioned on the sled as shown in Figure 90. A dynamic load was applied to the hose assembly at a rate of 65.5 feet per second. The force applied caused the hose to pull free of the elbow end fitting attachment at a peak load of 958 pounds. The valve was not damaged and performed properly following the test load application. A posttest view of this test may be seen in Figure 91.

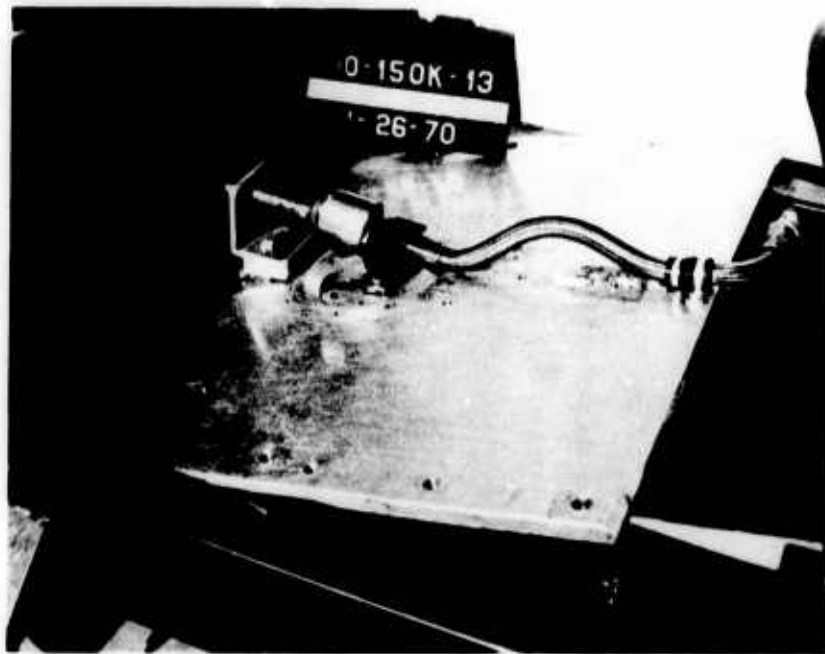
Figure 93. View of A1-1/2 Valve After Dynamic 75-Degree Impact Test.

After manual actuation, the valve was then rechecked and found to function properly. The valve was reinstalled on the sled, the flow was checked, and the valve was subjected to a 75-degree impact load at 63.5 feet per second. The valve nipple yielded in bending but did not fail. The valve permitted only a few drops of fluid leakage following impact load application and then sealed completely. The "B" nut and elbow hose end fitting did not fail (Figure 93).

The operating mechanisms of the A1-1/2 check valves which were subjected to the various dynamic and static applied loads in this test series received no permanent damage. However, the aluminum bulkhead nipple of the valve was bent, and the threads were damaged in the dynamic 75-degree impact and static bending tests.

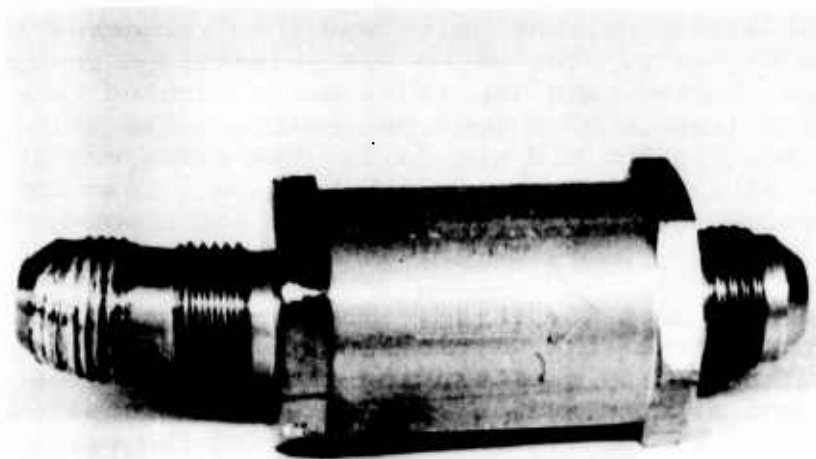
Figure 94. View of A1-1/2 Valve After Static Bending Test.

The valve resisted an applied bending load of 2,640 pounds prior to failure of the threads on the valve nipple. The valve nipple was distorted upward prior to failure. The valve performed properly when checked both prior to and following the static test. Figure 94 shows the valve after removal from the test fixture.

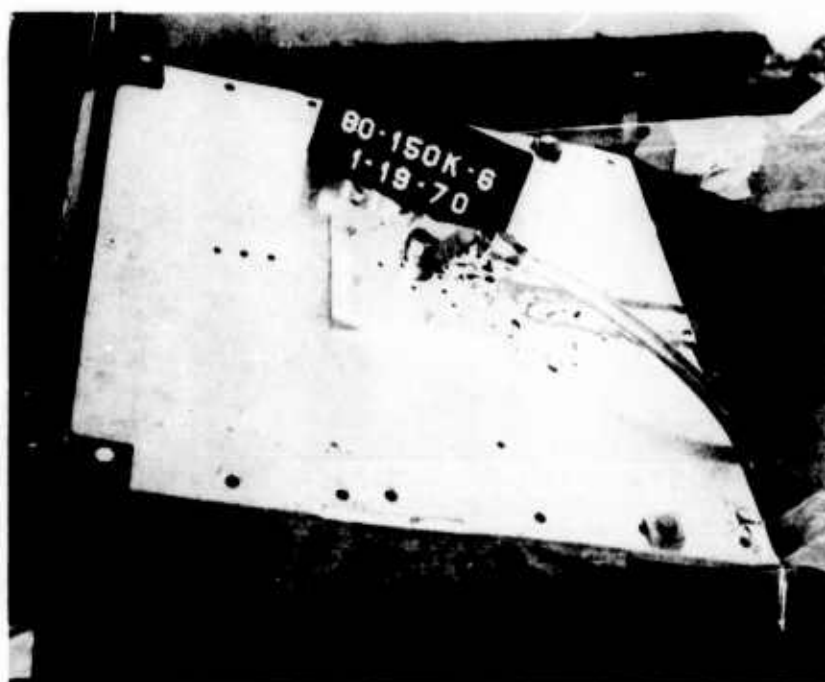
Figure 95. View of S.S.-1/2 Valve After Dynamic Bending Test.

Dynamic Bending - Test No. 80-150K-6: The valve and hose assembly were positioned on the sled in a manner similar to the setup shown in Figure 90. A dynamic load was applied to the hose assembly at a rate of 65.2 feet per second. The force applied caused the straight end fitting of the hose to fail at a peak load of 1,190 pounds. The snap ring in the "B" nut failed and permitted the remainder of the hose end fitting to pull free of the "B" nut and valve nipple. The valve was not damaged and performed normally following the test. A post-test view of the test setup is shown in Figure 95.

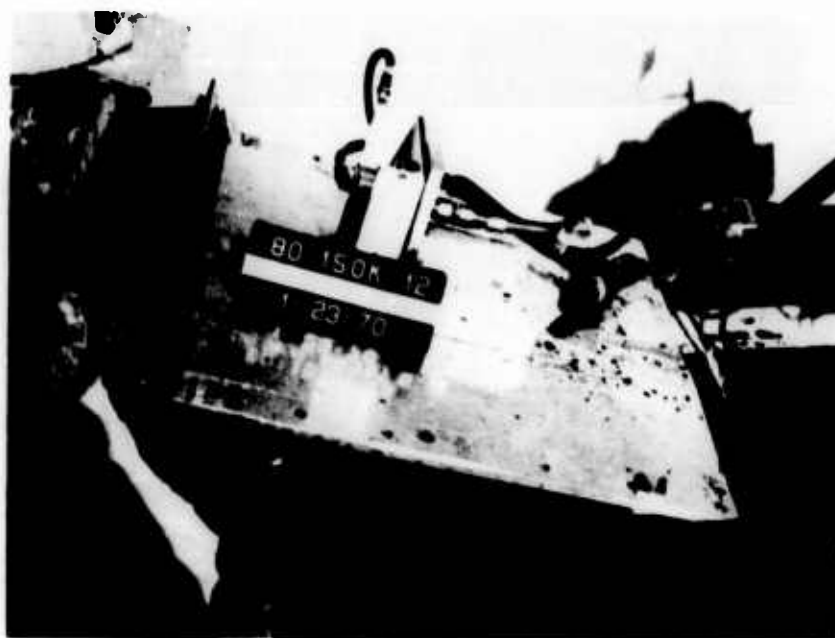
Figure 98. View of S.S.-1/2 Valve After Dynamic Tension Test.

A dynamic load was applied to the hose assembly at a rate of 65.1 feet per second. This dynamic loading resulted in a hose pull-out from the end fitting located opposite the valve end of the hose assembly (Figure 98); the pull-out load reached 1,015 pounds. The valve did not permit any leakage in the reverse direction following load application.

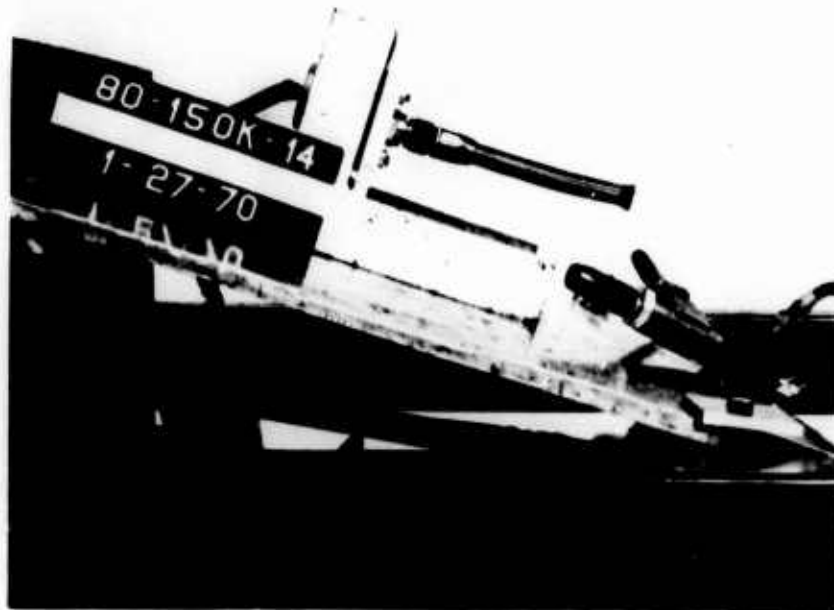
Figure 99. View of S.S.-1/2 Valve After Dynamic Tension Test.

The valve and hose assembly were subjected to dynamic loading at a velocity of 65.8 feet per second. The hose end fitting pulled off the hose at 846 pounds (Figure 99). The valve remained sealed and did not leak.

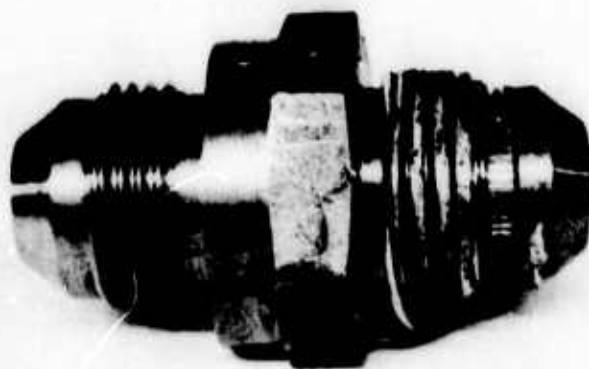
Figure 100. View of S.S.-1/2 Valve After Static Bending Test.

Static Bending - Test No. SK-17: The valve was positioned on the tensile test machine as shown in Figure 89. The static bending load was applied with an effective moment arm of 1-1/2 inches and at a rate of 1 inch per minute. The valve resisted an applied bending load of 2,550 pounds prior to the attachment linkage "B" nut pulling off the valve nipple. A view of this valve following removal from the test fixture is shown in Figure 100.

The operating mechanisms of the S.S.-1/4 and S.S.-1/2 check valves also received no permanent damage as a result of the applied loads. The continued load application on the static bending test did, however, begin to distort the cone point (end plug) of the nipple which was installed in the aluminum test fixture. As the aluminum threads failed, the valve was pulled from the fixture.

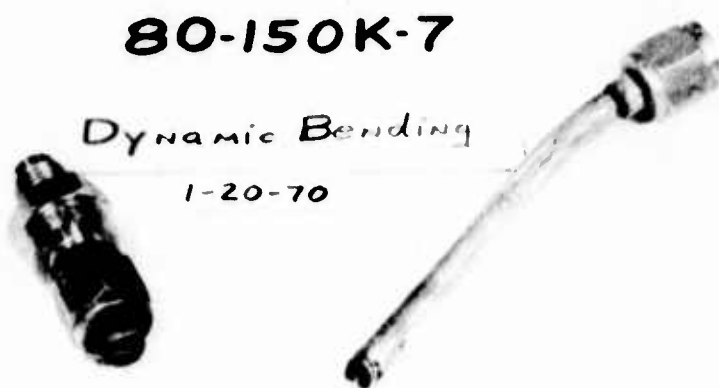
Figure 102. View of S.S.-1/4 Valve After Dynamic Bending Test.

Dynamic Bending - Test No. 80-150K-7: The mounting setup for the valve and tube assembly was similar to that shown in Figure 101. A load was applied to the 1/4-inch hose assembly at a rate of 65.2 feet per second. The force applied caused the tube to fail in tension at the top of the "B" nut as shown in Figure 102. The peak load recorded was 650 pounds. This dynamic load caused the valve to permit a leakage of 34 cc/min following the dynamic load application. The valve was then subjected to a flow in a normal direction and, when rechecked in the reverse direction, leakage still occurred. The direction of flow was again changed and, upon return to reverse direction, the valve sealed completely.

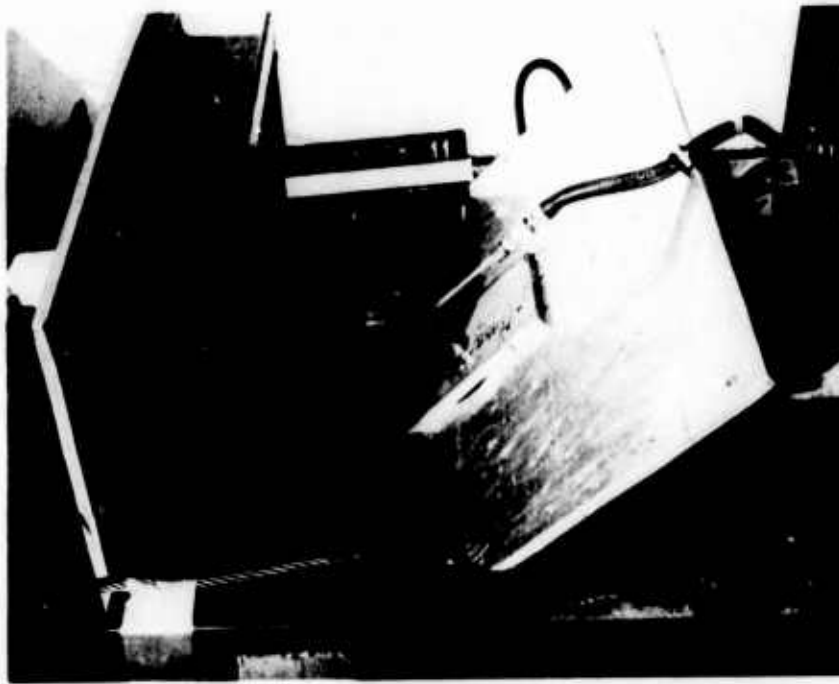
Figure 103. View of S.S.-1/4 Valve After Dynamic 45-Degree Impact Test.

45-Degree Dynamic Impact - Test No. 80-150K-11: The valve and tube assembly were positioned on the sled as shown in Figure 99. The tube and "B" nut installed on the valve nipple were struck with a lead impact head at the rate of 63.4 feet per second. The impact head distorted across the top of the "B" nut and completely flattened the tube, resulting in tube failure (Figure 103). A posttest pressure check of the valve

revealed that the valve was not damaged by the impact and performed normally.

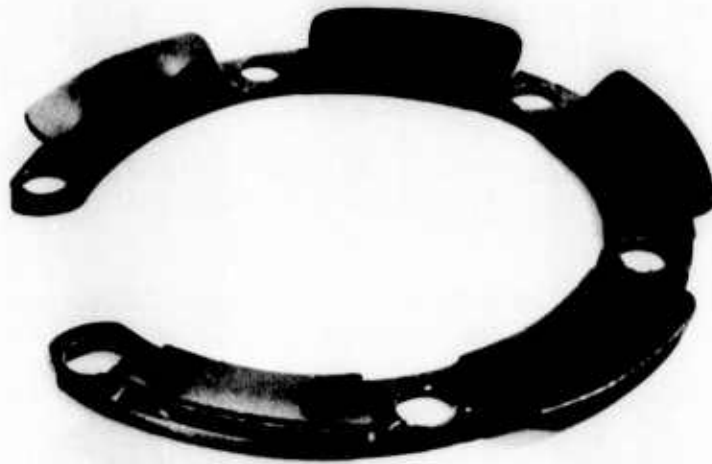
Figure 111. -648 Retainer After Tension Loading.

The six tension drops of the two retainer designs resulted in average values that were very close. The -648 retainer averaged release loads of 1,068 pounds, and the -669 retainer averaged release loads of 1,065 pounds. The tension values for the -648 retainer were more closely grouped than those of the -669 retainer. Figure 108 illustrates a typical tension setup immediately following release. Figure 111 illustrates a typical -648 retainer and Figure 112 illustrates a typical -669 retainer following tension loadings. Detailed test results are presented in Table XIII.

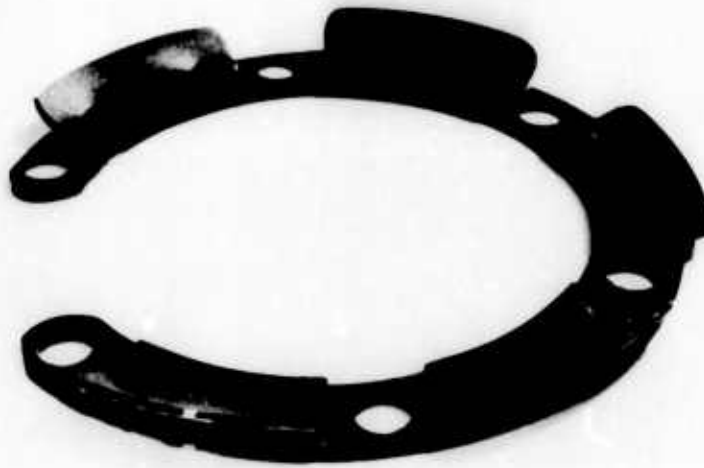
Seven drops were made with the two retainer designs in the bending loading configuration. The loads were applied with a moment arm of 2.4 inches. The three drops with the -648 retainer resulted in an average release load of 995 pounds. Four drops were made in bending with the -669 retainer. The first drop of this series did not result in release due to fixture failure. The faulty fixture was replaced and the three additional bending drops were made. The average release load for the -669 retainer was 1,377 pounds. Release loads within each type were very consistent with the values for the -648, being very closely grouped.

Figure 115 illustrates a typical -648 retainer and Figure 116 illustrates a typical -669 retainer following release from a bending loading mode.

Figure 115. -648 Retainer After Bending Loading.

Both retainers appeared to be usable for the purpose for which they were designed and superior to previous designs. However, modifications to improve the directionality should be investigated. A reasonable indicator of the directionality of the design is the ratio of the shear failure load to the tensile failure load. As the data in Table XIII show, this ratio is approximately 2.4 for both of the designs tested. However, since the radial cord fittings currently in use have a shear load capability which is about half of their tensile load ability, it would appear that the attachment should ideally approach this characteristic. Obviously, some modification to the current design would be required to achieve this objective. Also, the need and effect of the nonsymmetrical design (horseshoe shape) should be investigated.

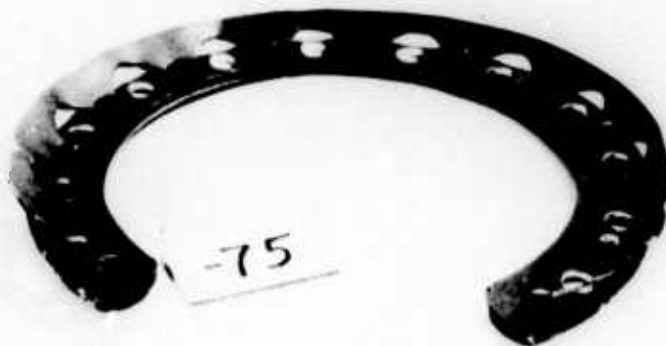
Figure 116. -669 Retainer After Bending Loading.

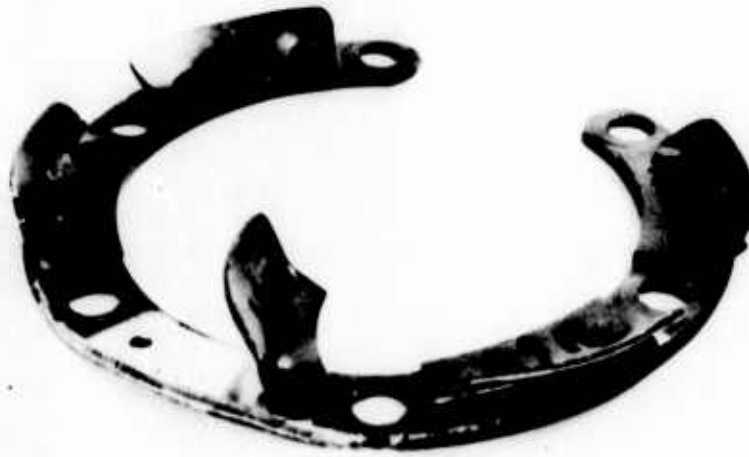
Figure 117 illustrates a typical -648 retainer and Figure 118 illustrates a typical -669 retainer following release from a shear loading mode.

Figure 117. -648 Retainer After Shear Loading.

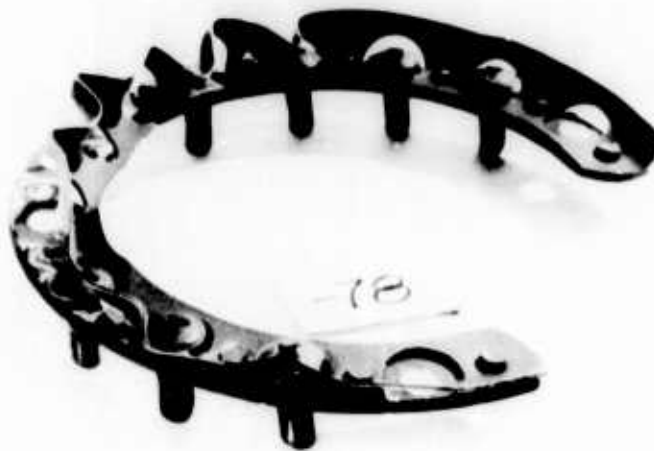
Figure 118. -669 Retainer After Shear Loading.
